# California Department of Forestry and Fire Protection

## INVESTIGATION REPORT

**NAME:** Rice Fire

**CASE NO.** 07-CDF-572

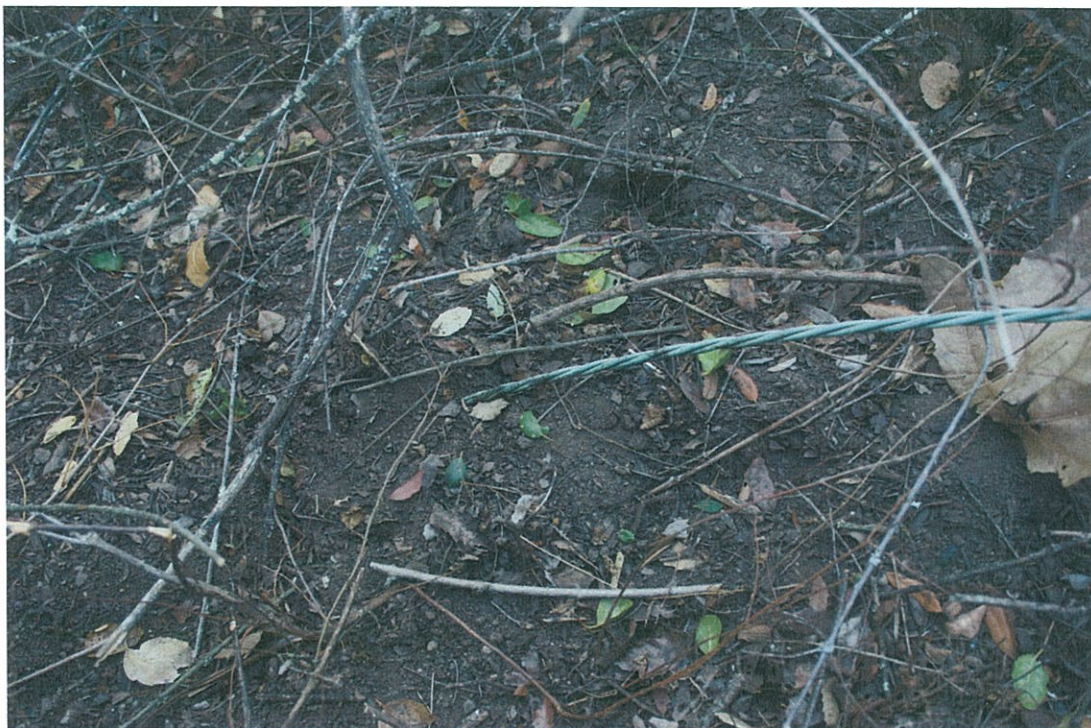
P-8 MG View of end of power line

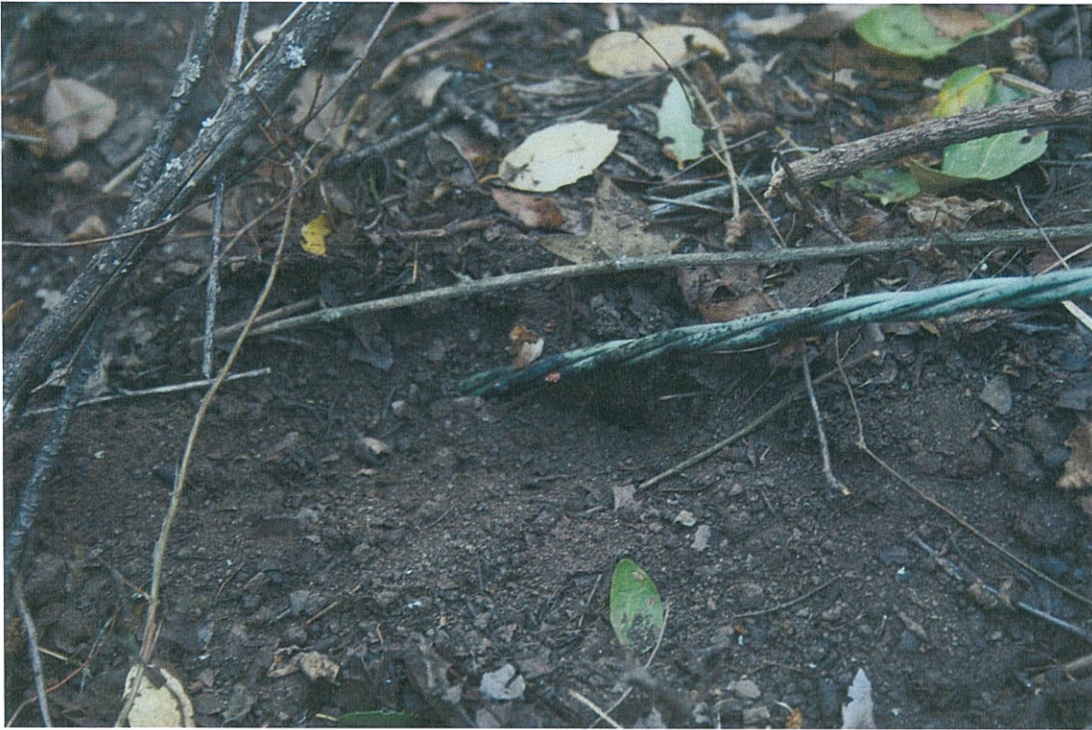
21 Power lines – During my investigation of Specific Origin Areas #1 and #2 I located  
22 downed power lines. Each line showed areas of spackling and arcing. Witness  
23 statements place the fire as being small in size near the areas I identified as the  
24 Specific Origin Areas and the power going out between 4:00 and 4:15 AM, which  
25 correlates to the estimate provided by SDG&E. During the course of the  
26 investigation I eliminated all other causes for the fire, determining the Rice Fire to  
27 be a power line caused fire.

P-9 MG View of arcing on power line

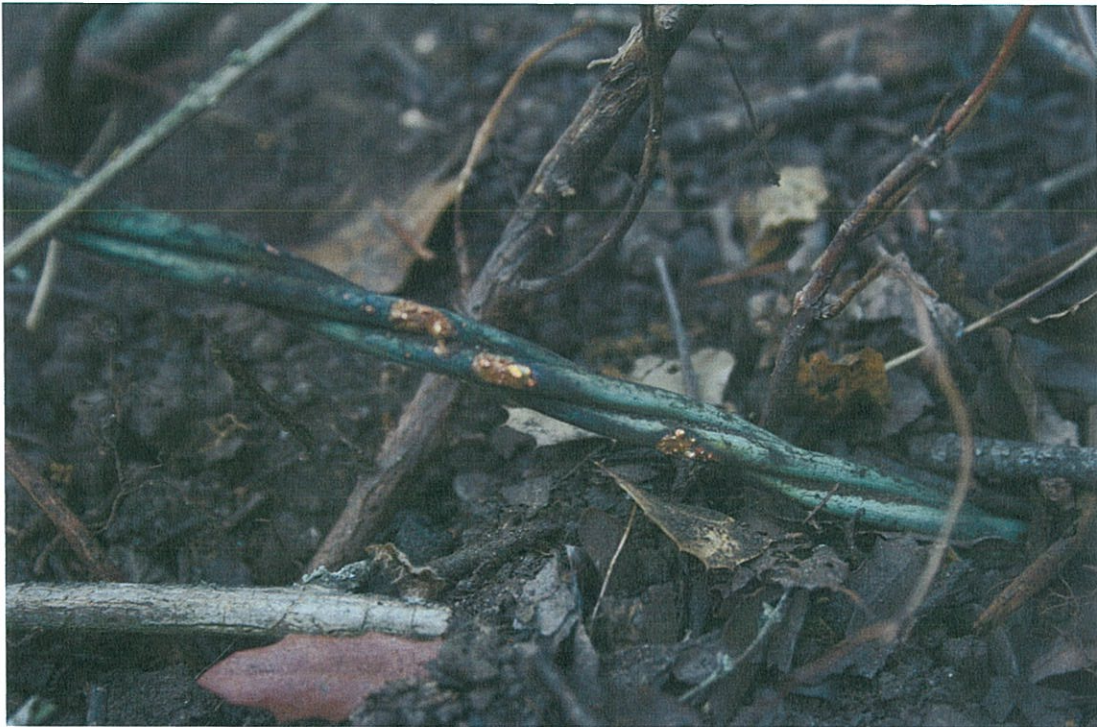
P-10 MG Close-up view of arcing

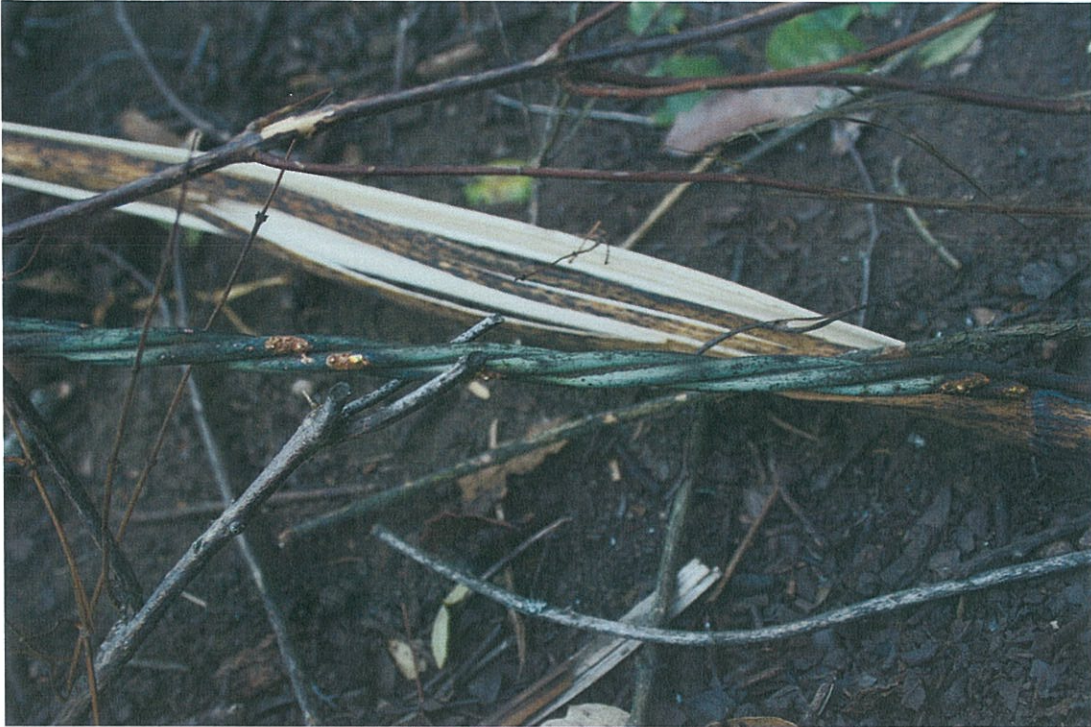
P-11 MG Close-up view of arcing

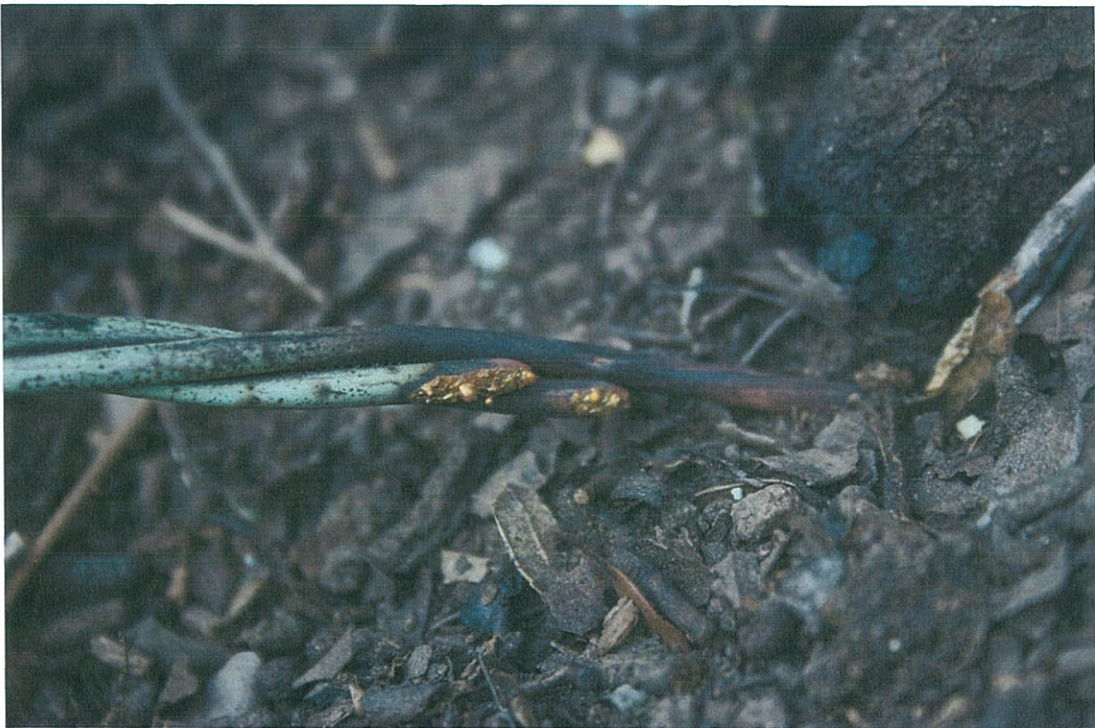
P-12 MG Close-up view of arcing

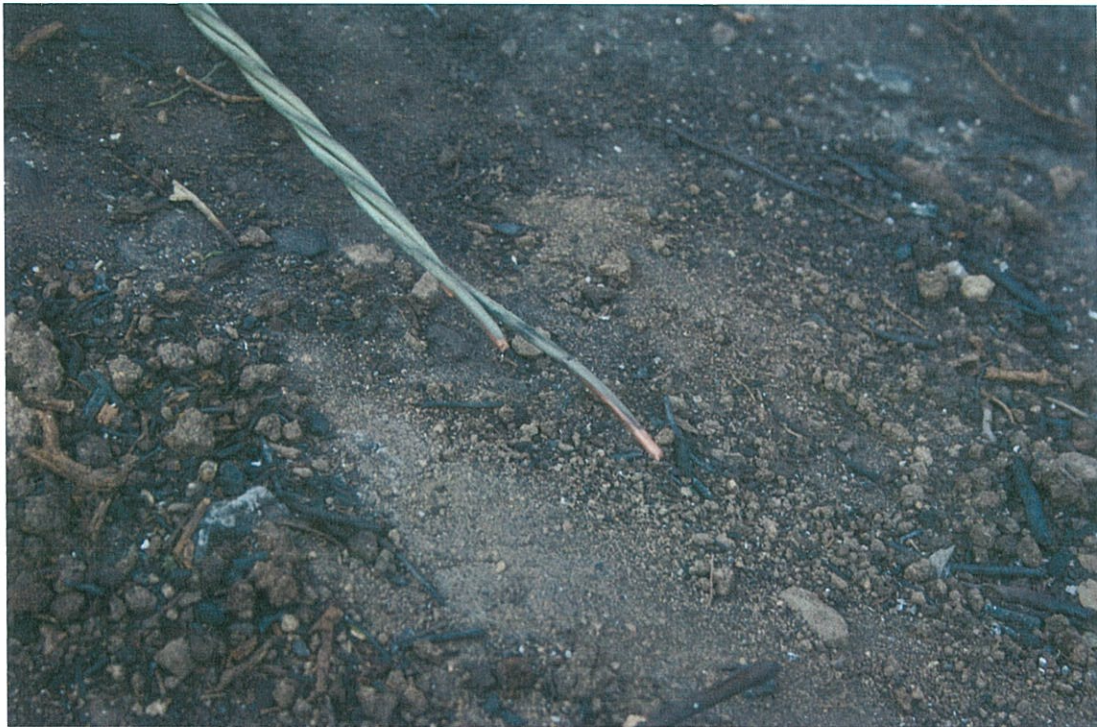
P-14 MG View of broken power line

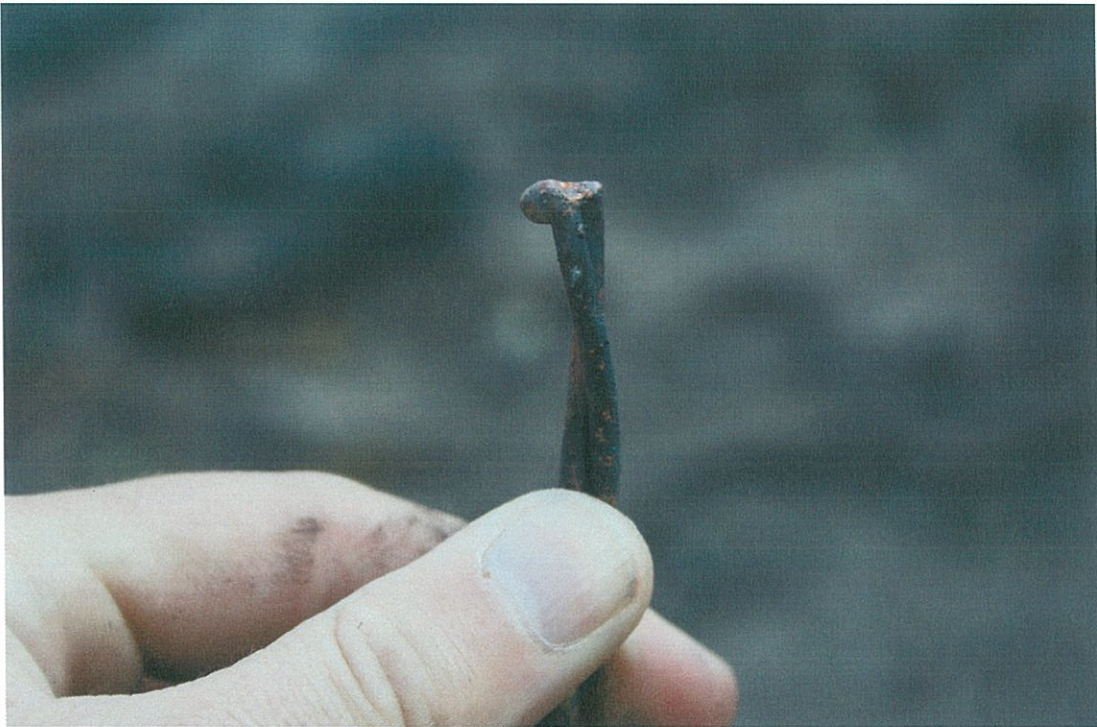
P-16 MG View of beading on power line

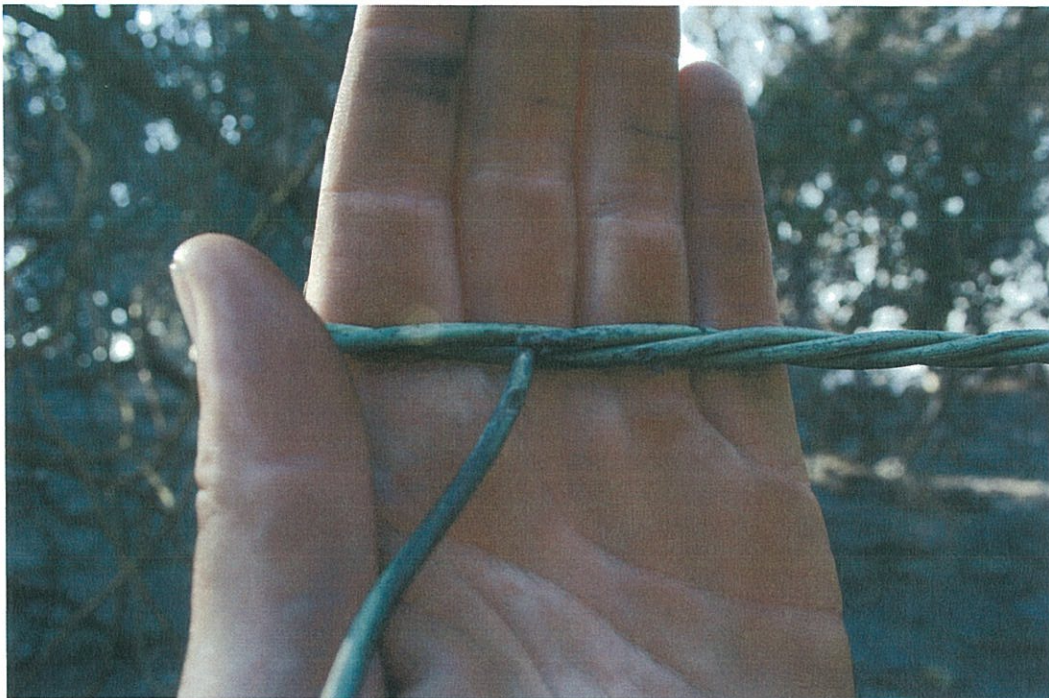
P-52 MG View of arcing and damage to power line

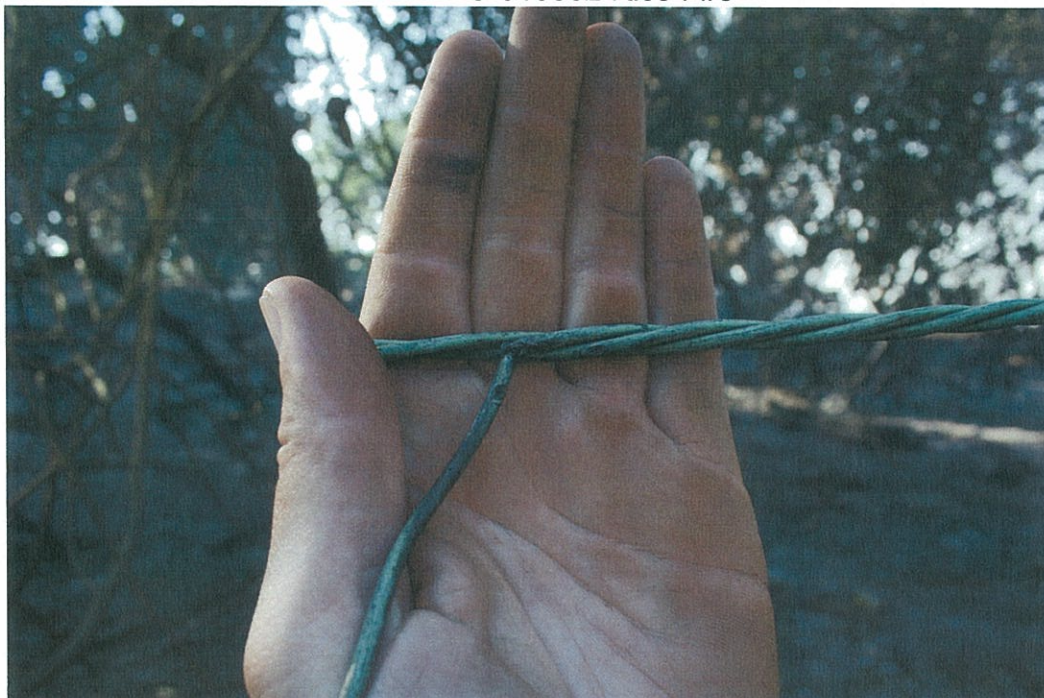
P-53 MG View of arcing and damage to power line

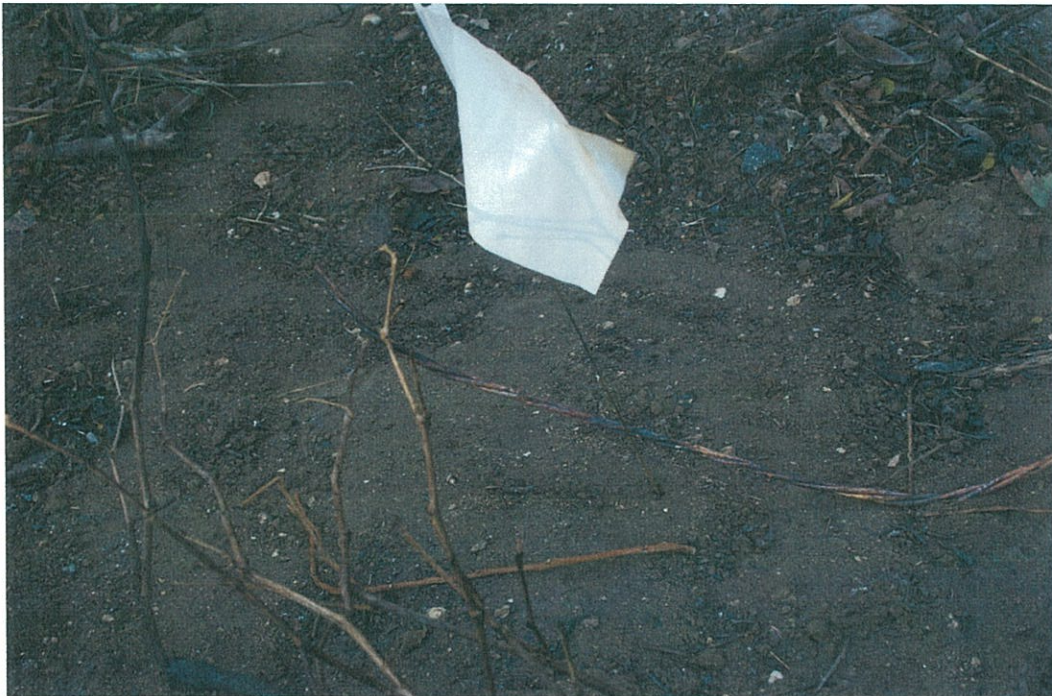
P-56 MG View of damage to power line

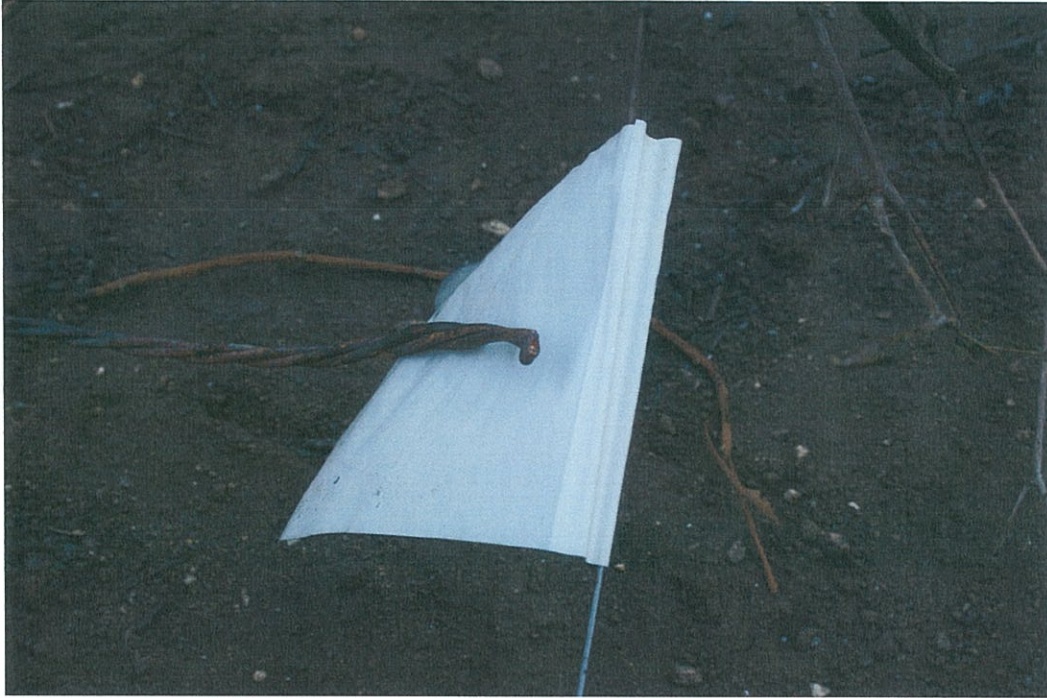
P-57 MG View of beading on end of power line

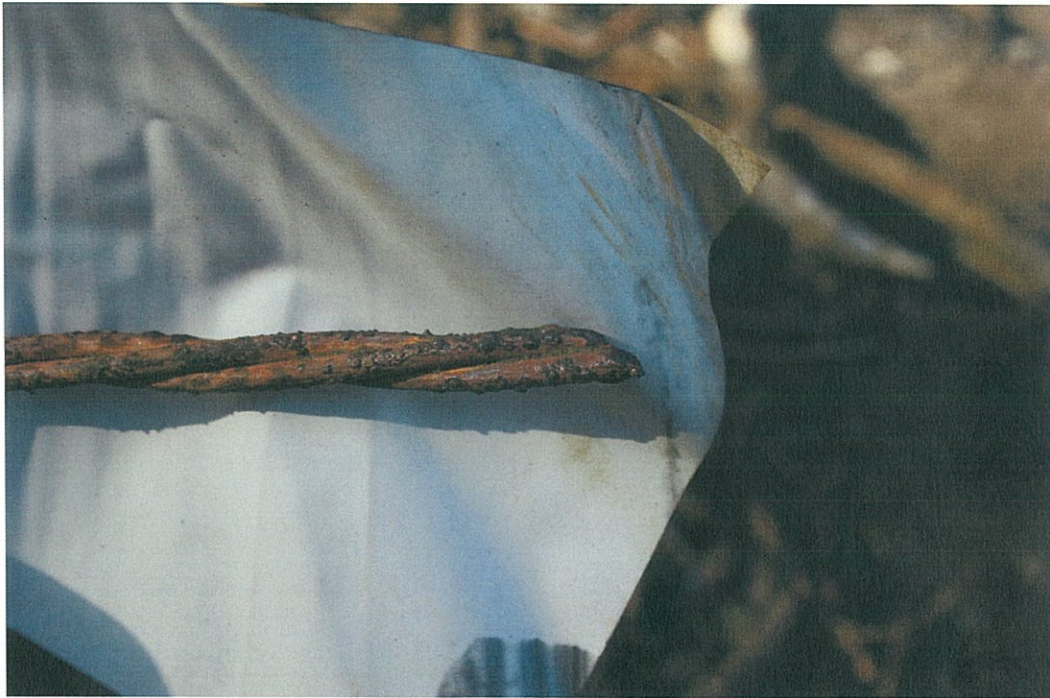
P-58 MG Close-up view of damage to power line

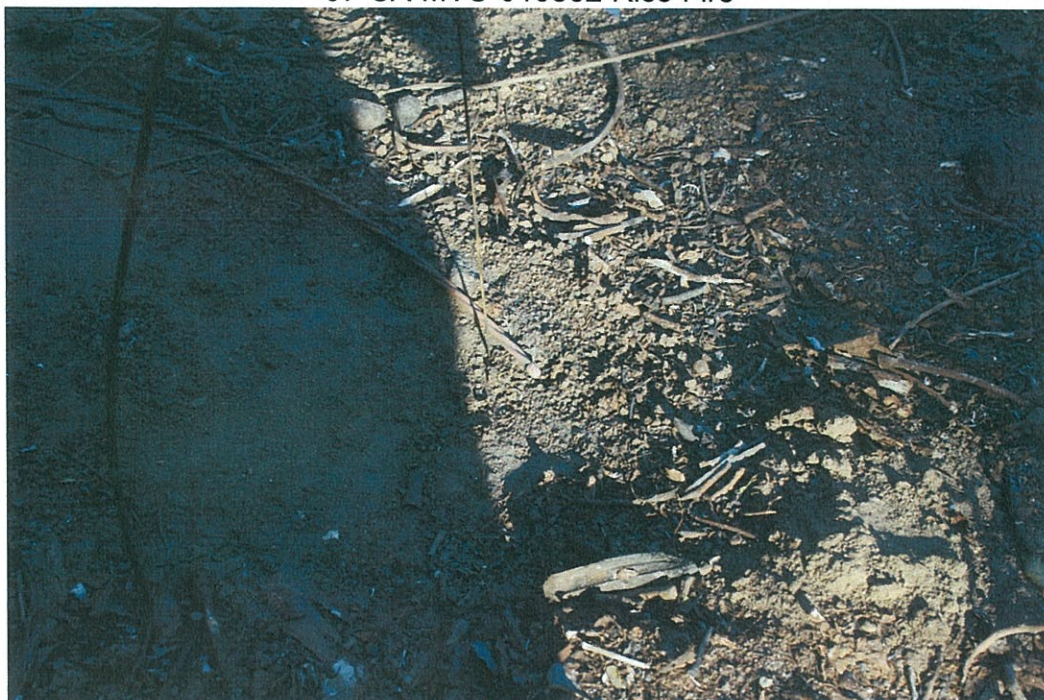
P-59 MG View of beading on end of power line

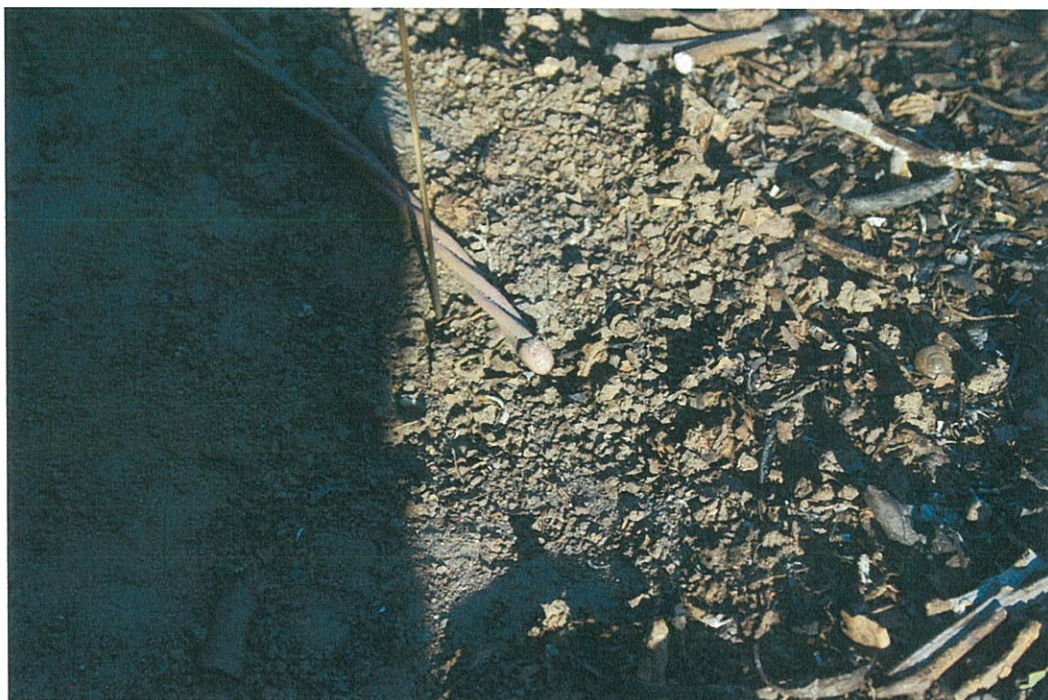
P-60 MG Close-up view of beading

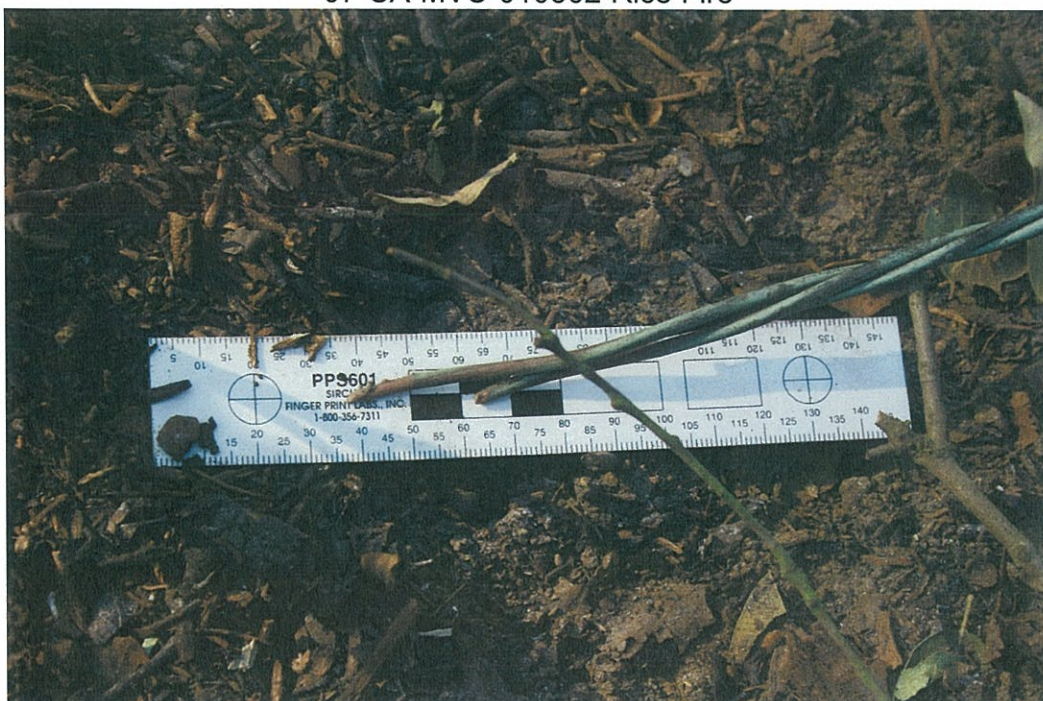
P-93 MG Close-up view of damage power line

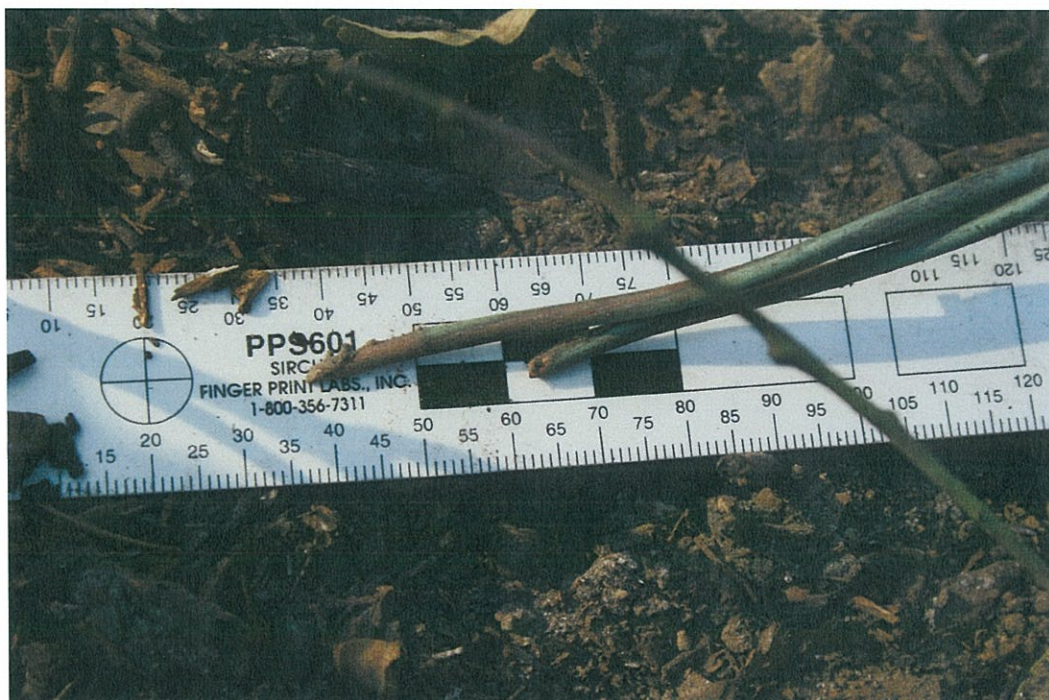
P-94 MG Close-up view of damaged power line

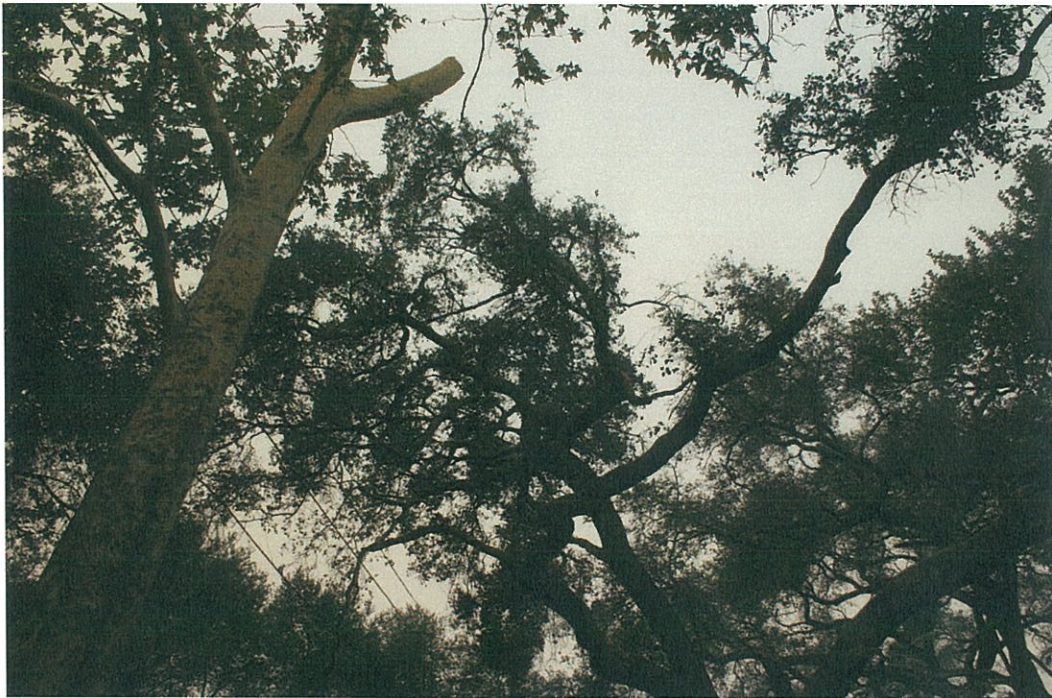
P-6 MG View of area where sycamore was cut

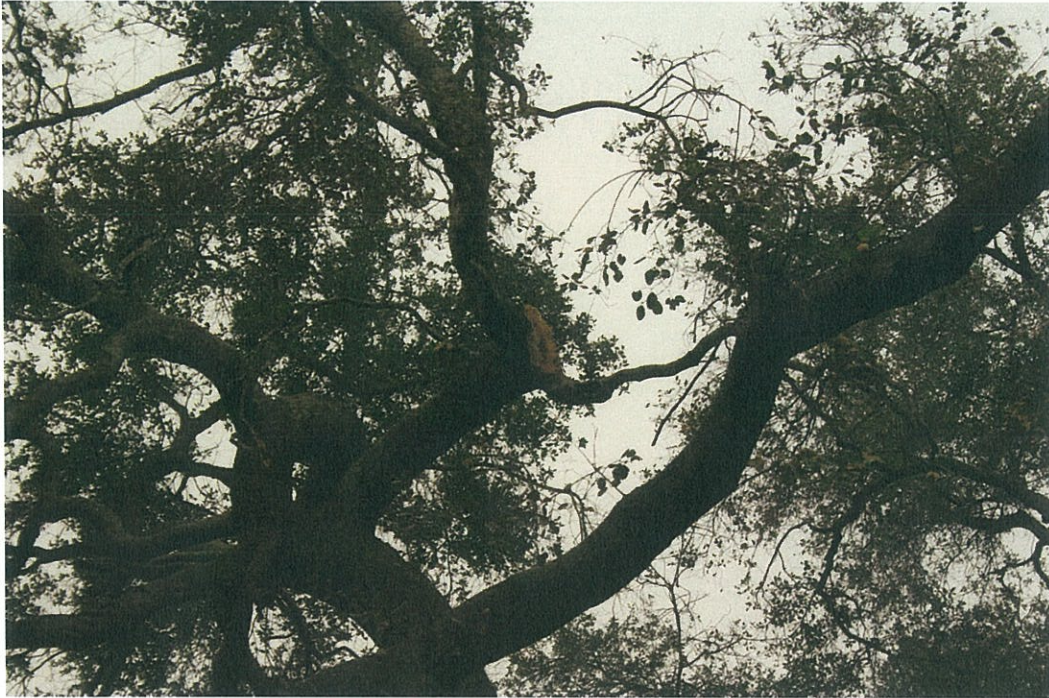
P-7 MG View of damaged oak
